**CWA COMPLIANCE EVALUATION INSPECTION REPORT**  
**U.S. ENVIRONMENTAL PROTECTION AGENCY, REGION 5**

Compliance Evaluation Sampling Inspection

FOIA EX 6 [REDACTED] Pork, Inc  
Rural Route 1 Box 158  
Sigel, IL 62462  
Shelby County  
38.243N, 88.482W

April 3, 2014

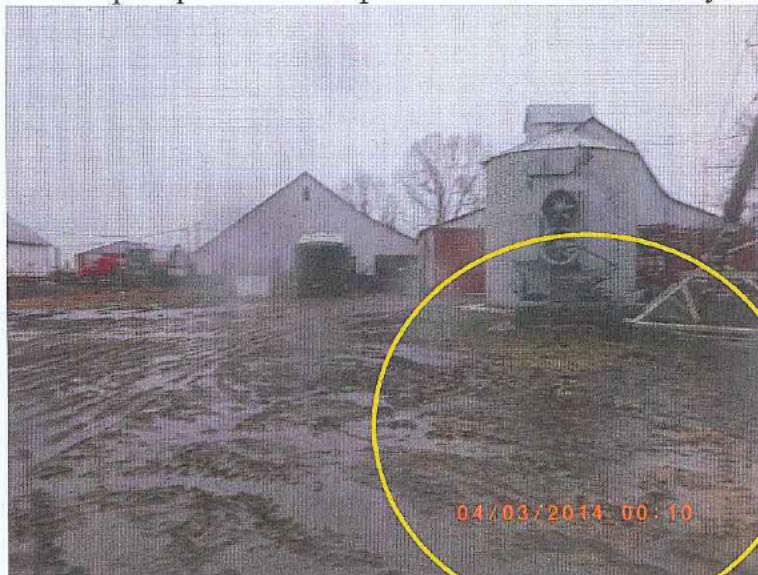
5: IMGP0008

North of the confluence of the stream and the roadside ditch, there are five feed bulk bins. There was feed spilled on the ground around the bulk bins which could be transported with the precipitation to the perennial unnamed tributary.

Description: Feed spilled on the ground near the bulk bins.

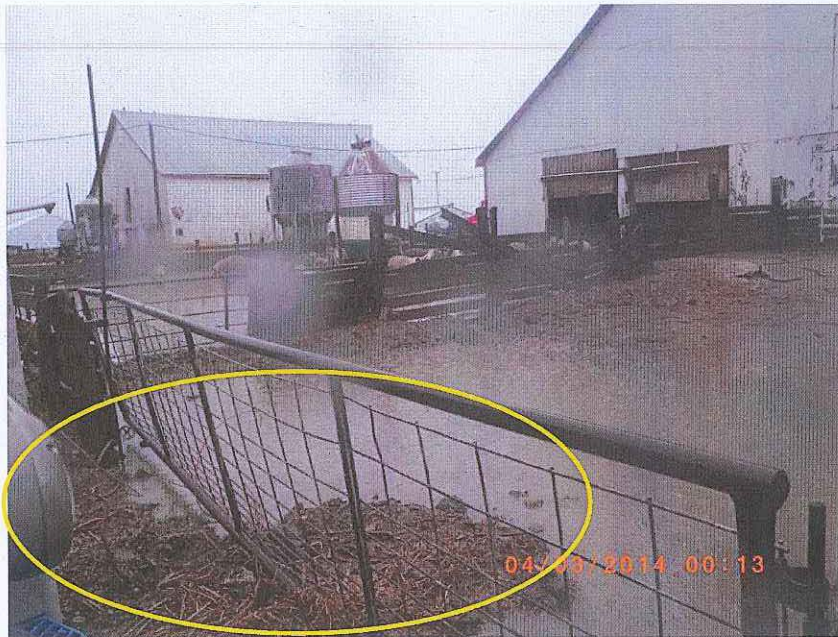
6: IMGP0013

Description: On the day of the inspection, the berm at the southern edge of the open pen was effective at preventing the process wastewater from flowing to the south and to the perennial tributary.

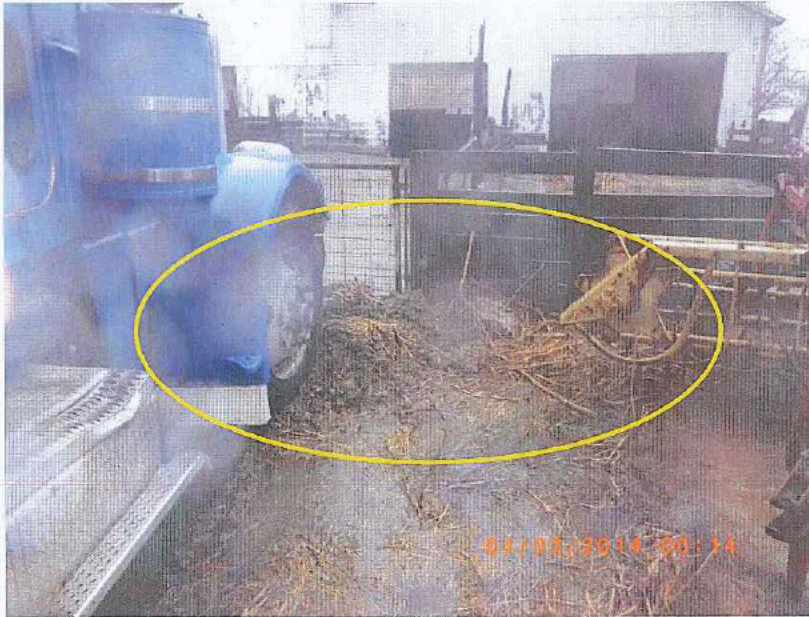
7: IMGP0014

Description: The berm at the southern edge of the open pen of the East Barn. The process wastewater flowed to the west into the open pen of the West Barn.

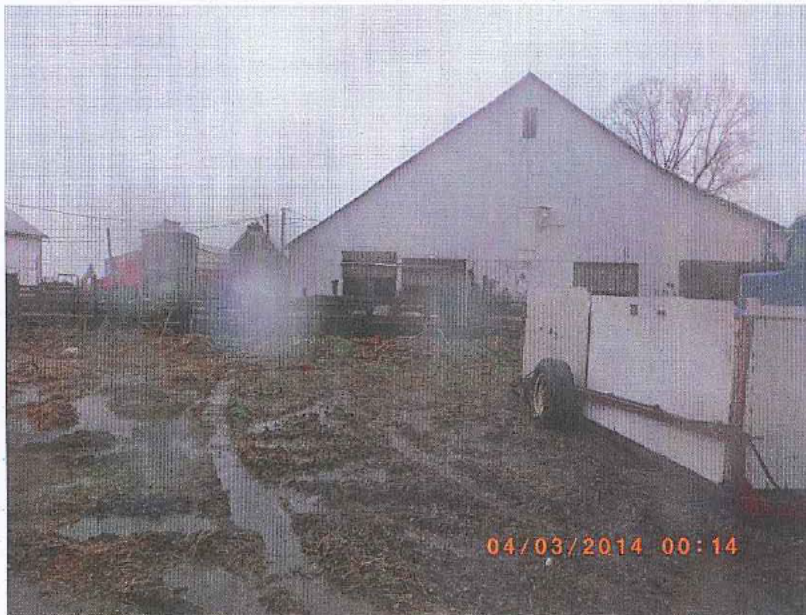
8: IMGP0015

The yard south of the East and West Barns was wet and rutted from machinery. There was spilled feed and sawdust in the yard that could be transported with precipitation to the perennial tributary. The sawdust is used to cover the mortalities in the Compost Pile.

Description: The yard south of the barns was very wet and rutted and there was spilled feed and sawdust on the ground in the yard.

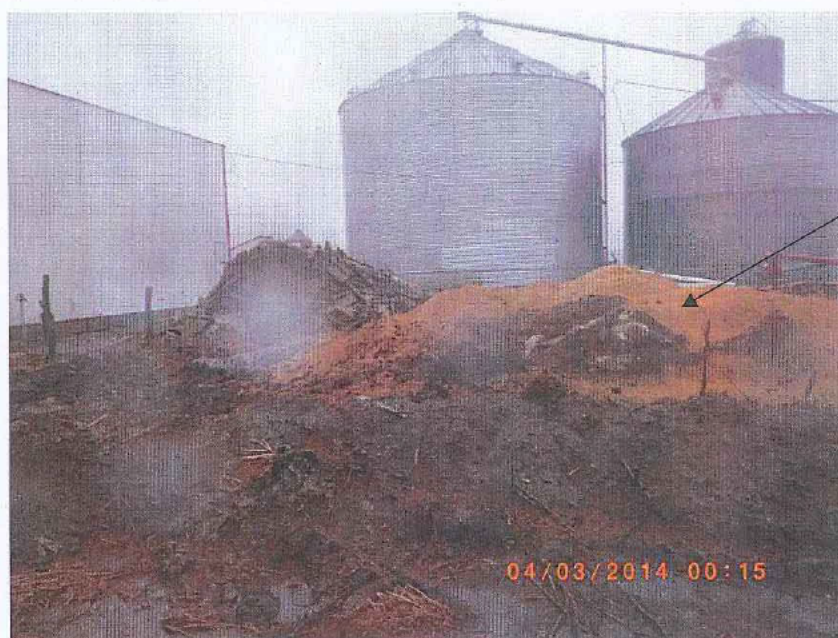
9: IMGP0016

On the day of this inspection, EPA observed that the mortalities in the Compost Pile were not covered properly. The facility manager stated that the young pigs had been placed in the Compost Pile the day before. EPA also observed that the berm on the southeast side of the Compost Pile appeared to be compromised. The berm wall in this area was comprised of a different material than the rest of the berm and appeared to be compost material. Bones were observed in the berm at this section. Leachate from this material was observed in puddles and flow pathway leading from the Compost Pile. The pathway flowed to the southeast to the east of the Wash Bay and then south to the perennial tributary.

Description: The Compost Pile with a two foot high berm around it. The mortalities were not properly covered. Mr. FOIA EX. 6 (Personal) stated that he lost about 100 young pigs the day before. Black arrow points to an exposed mortality.

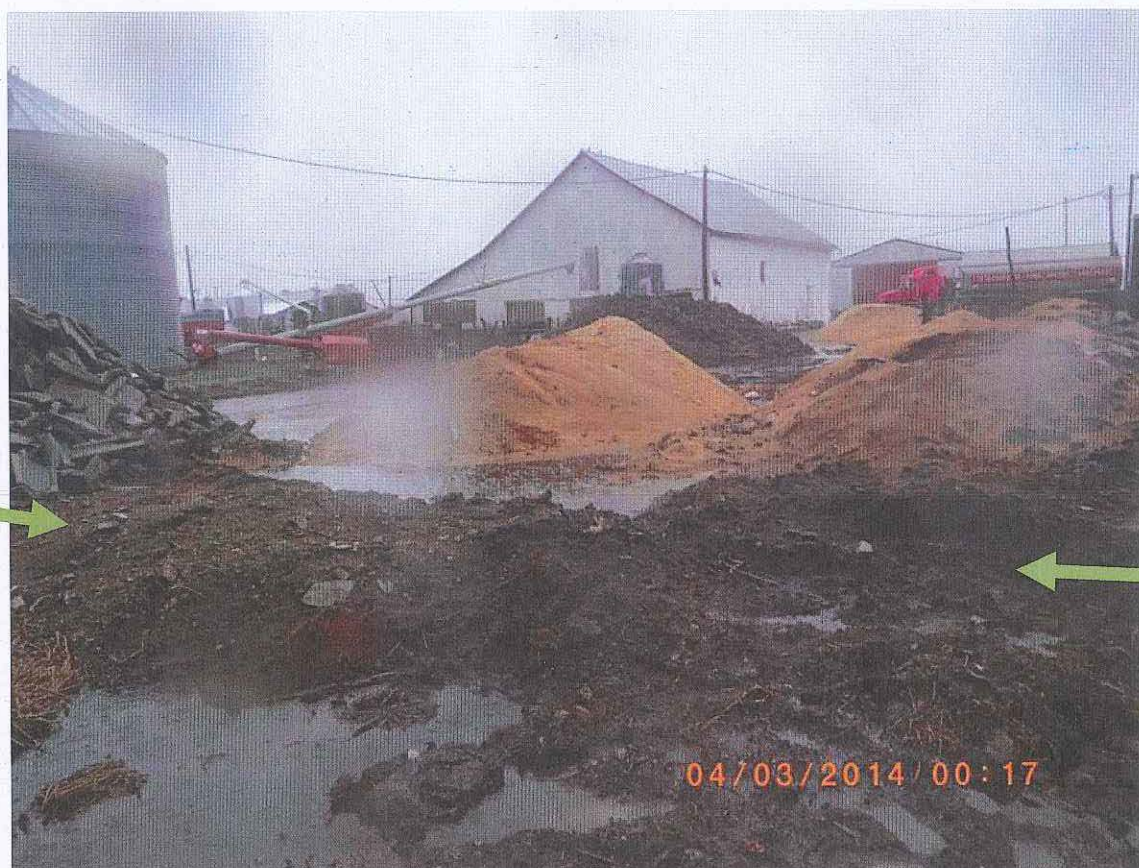
10: IMGP0019

Description: The southeast corner of the berm around the Compost Pile appeared to be comprised of compost material. Note the difference in color of the berm material. Green arrows denote areas of the berm of differing composition.

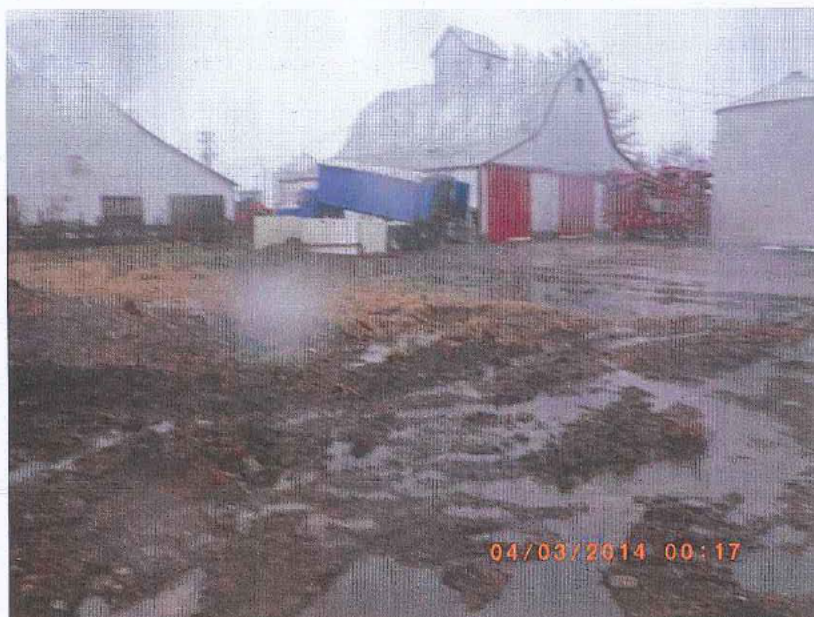
11: IMGP0020

Description: Leachate from the compost material in the berm was present in the puddles outside the compost pile.

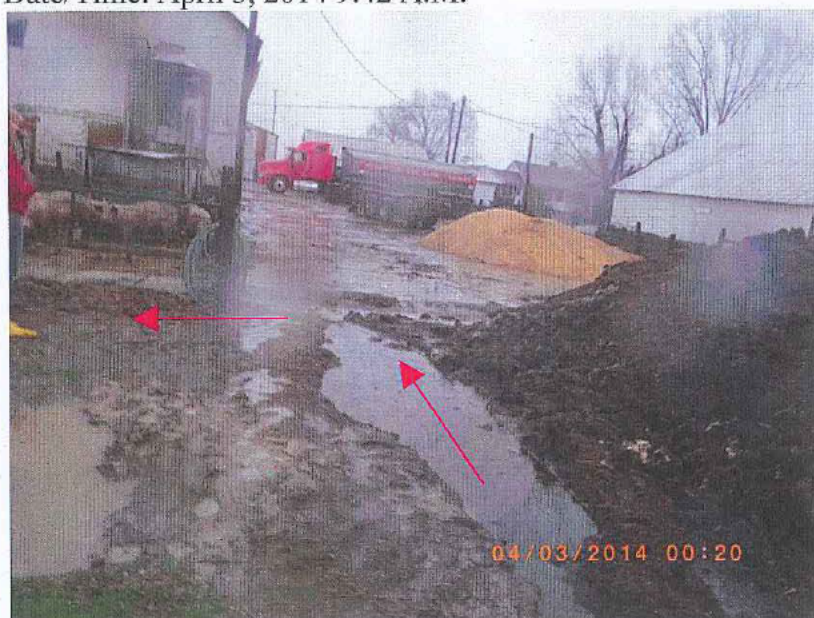
12: IMGP0022

Description: Leachate inside the berm of the Compost Pile flows to the northwest corner and then flows west. Red arrows denote location and direction of flow from compost pile.

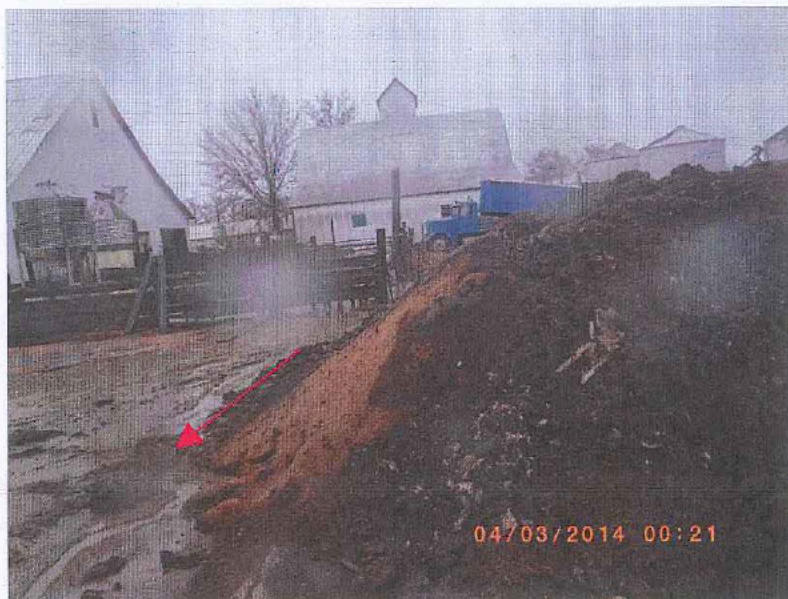
13: IMGP0023

Description: The flow of process wastewater from the East Barn flows to the West Barn north of the Compost Pile. Red arrow denotes location and direction of flow from the open pen of the East Barn.

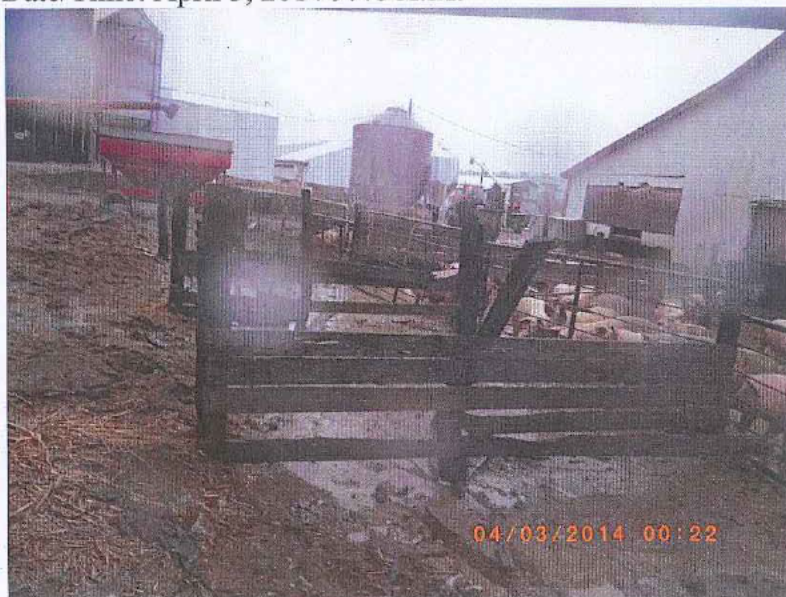
14: IMGP0024

Description: The flow of process wastewater from the East Barn and the Compost Pile goes to the west, south of open pen of the West Barn. Process wastewater from the West Barn also flows to the west.

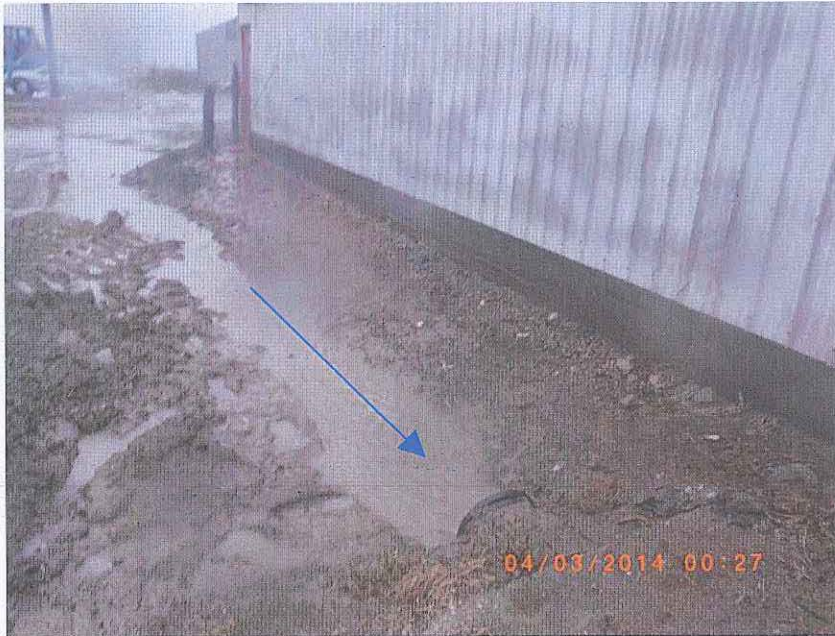
16: IMGP0027

West of the West Barn, a storm water pipe inlet lay on the ground. On the day of the inspection, there was flow into this pipe. This pipe outletted in a ditch approximately fifteen feet north of the perennial tributary. During the July 10, 2012 inspection, there was only an open gutter for the stormwater west of the West Barn. A pipe at the end of the gutter transported the flow to the ditch north of the perennial tributary. This gutter also was able to transport manure and process wastewater from the open pen of the West Barn that overflowed into it. After that inspection, the facility owner closed the gutter and added the storm water pipe.

Description: Water flowing into the storm water pipe. There

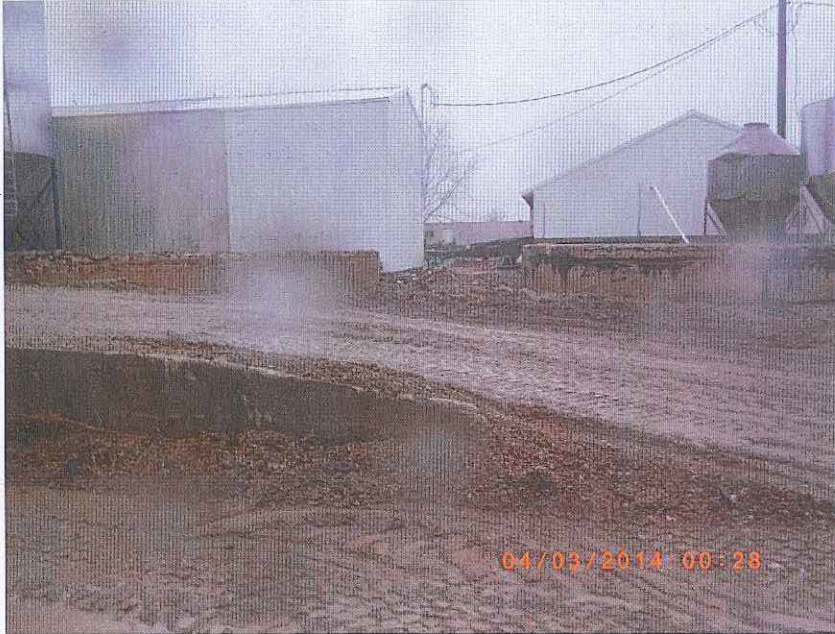
17: IMGP0028

To the west of the West Barn was a ramp for feed loading. There was a considerable amount of feed on the ground around the ramp that could be transported with the precipitation to the south and to the perennial tributary.

Description: Spilled feed on the ground around the silo area.

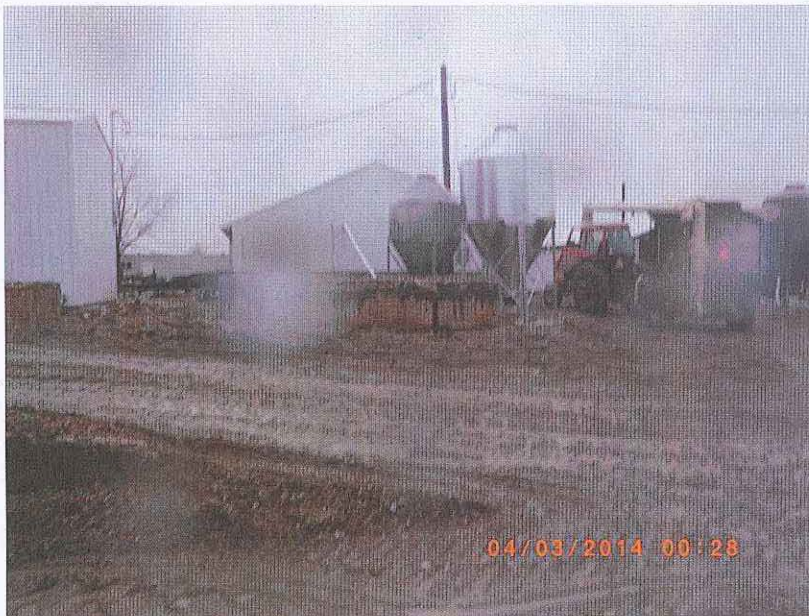
18: IMGP0029

Description: Spilled feed on the ground around the silo area. There used to be two silos on the concrete footings behind the ramp. In the fall of 2013, one collapsed and the other was taken down.

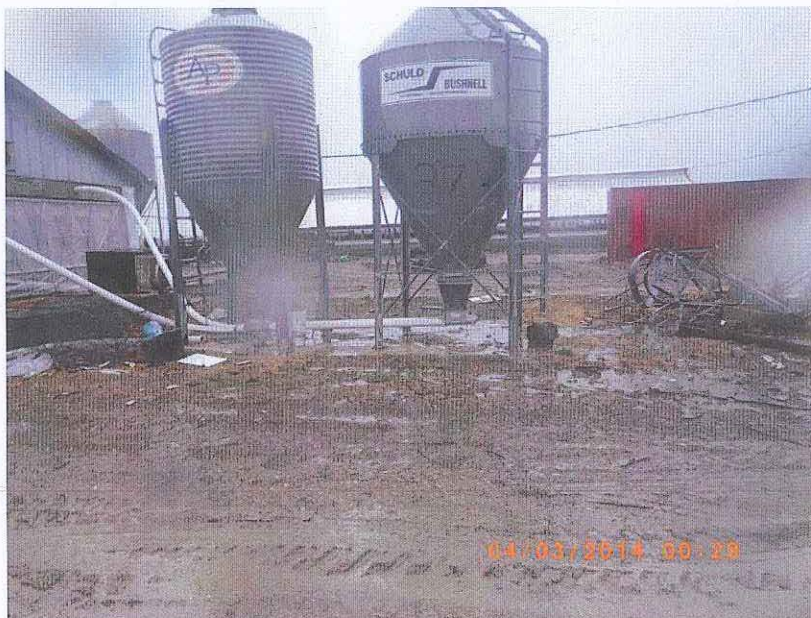
19: IMG0030

Bulk bins on the east side of the Finishers Barns had spilled feed below them that could be transported with precipitation to the unnamed tributary either directly or could flow with precipitation to the storm water pipe on the west side of the West Barn and then to the unnamed tributary.

Description: Spilled feed below the bulk bins.

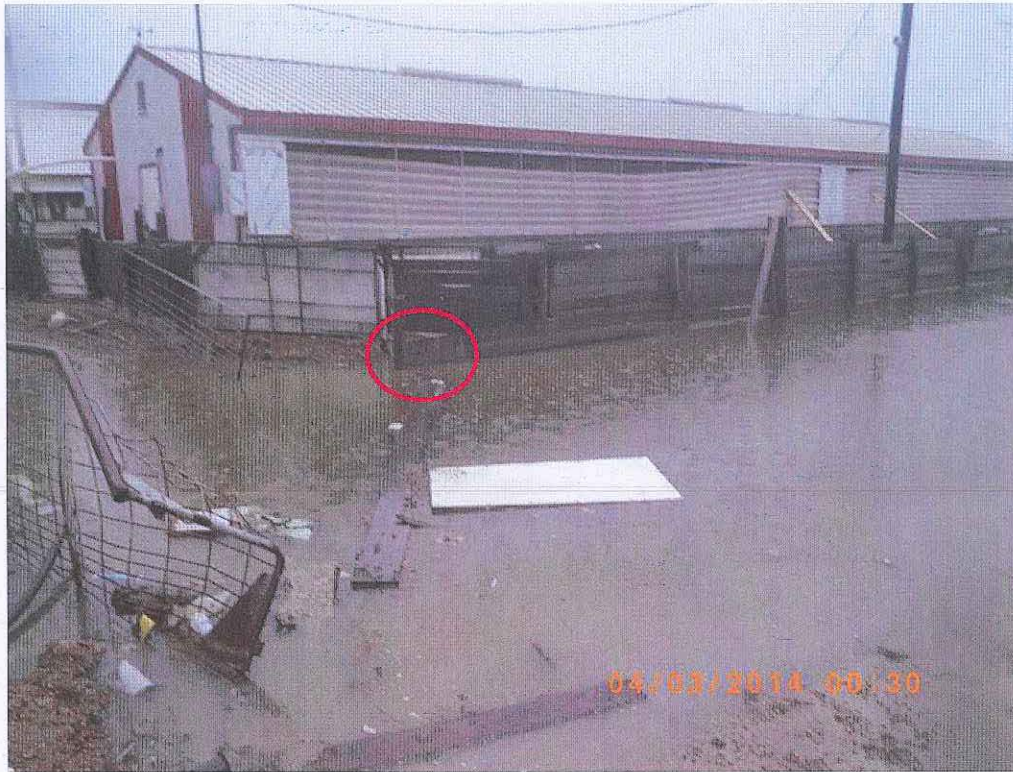
20: IMGP0032

Description: Hogs used to be penned between Barn #3 and Barn #4. When the silo collapsed, it fell in this area and spilled the contents of the silo in here. Hogs are no longer confined in this area and the fencing has been removed. In the photo, the red circle denotes where there is a blue mark on the board that indicates the location of a pipe inlet. In a previous inspection, this pipe was identified as joining the storm water pipe on the west side of the West Barn. Although there is standing water in this area, the farm manager said that the pipe was not capped and flow can still access the storm water pipe.

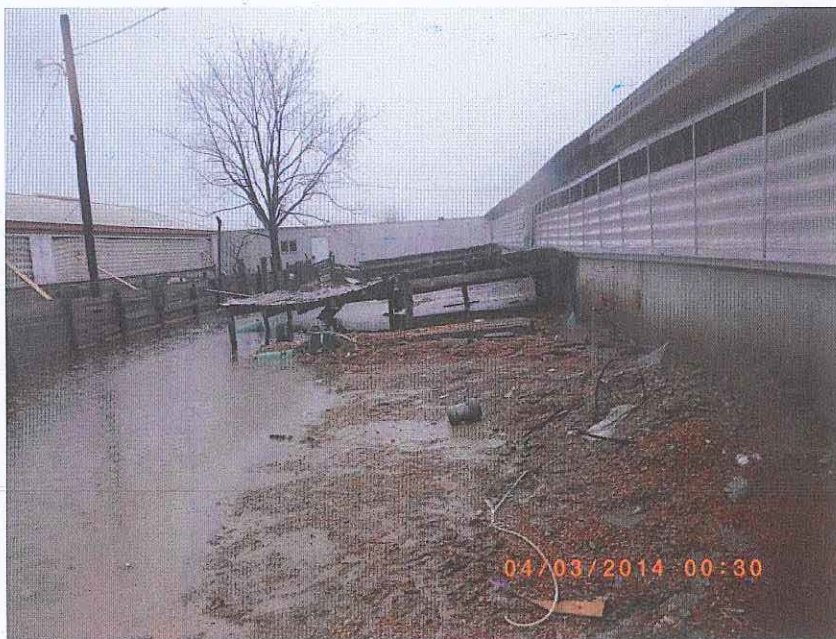
21: IMGP0033

Description: Fencing to confine hogs has been removed. Spilled grain is evident on the ground and can flow with precipitation to a pipe which outletted in a storm water pipe west of the West Barn.

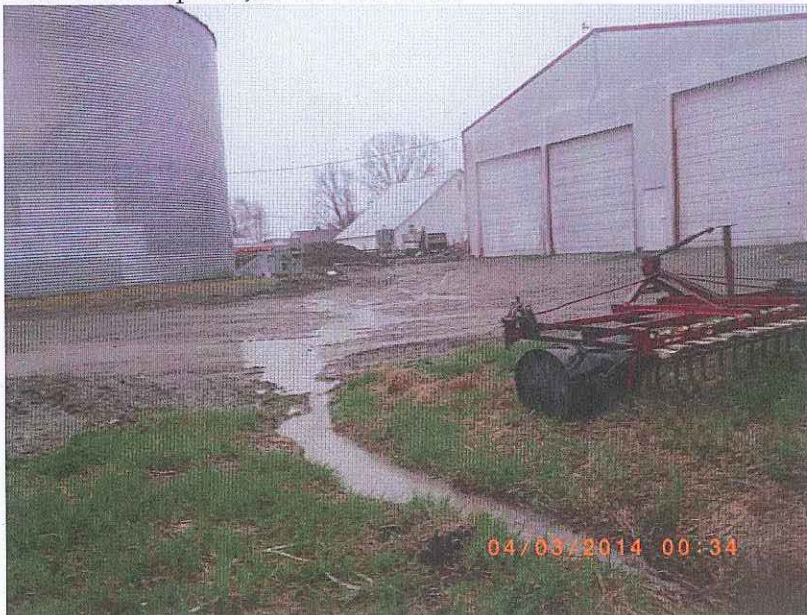
23: IMGP0037

Description: Flow of storm water from the production area to a ditch that is just north of the perennial tributary.

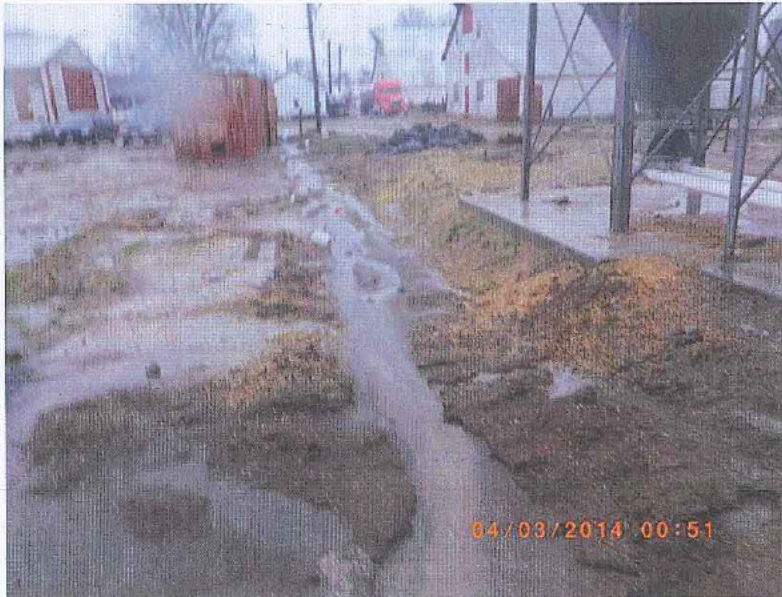
32: IMGP0055

Description: Storm water from the west side of Barn #6, outlets on the east side. Feed spilled on the ground can be transported with the precipitation.

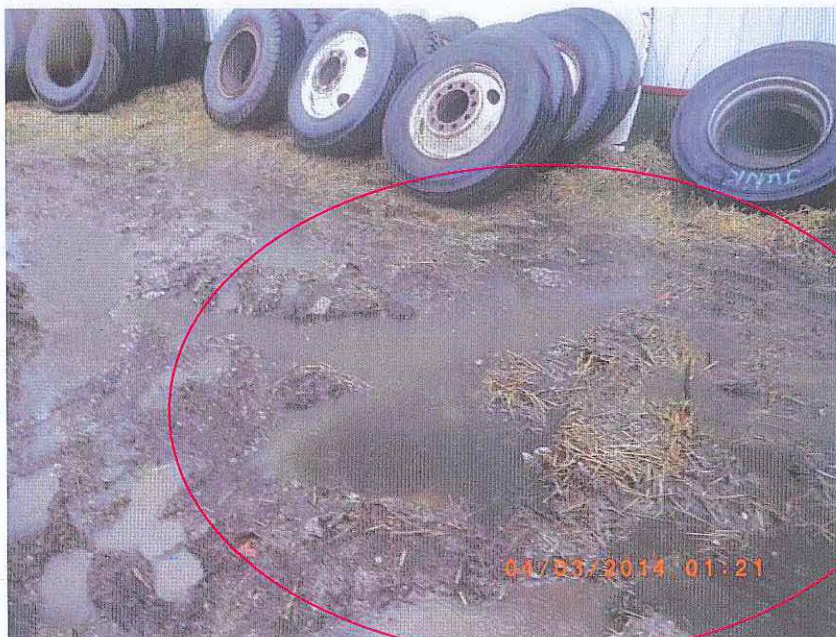
34: IMGP0057

Description: Note the plume of leachate in the puddle from the compost.

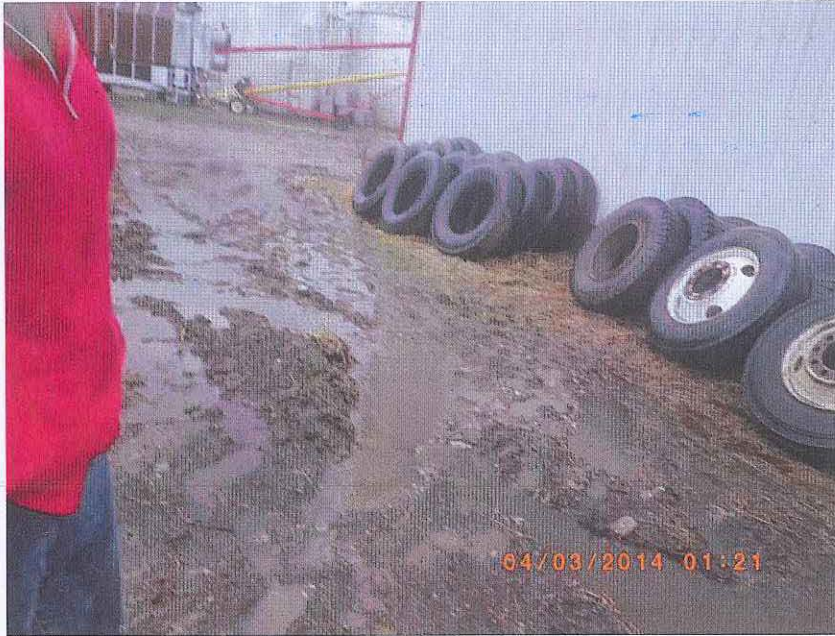
35: IMGP0058

Description: The flow of water from the puddle is unbroken all the way to the stream.

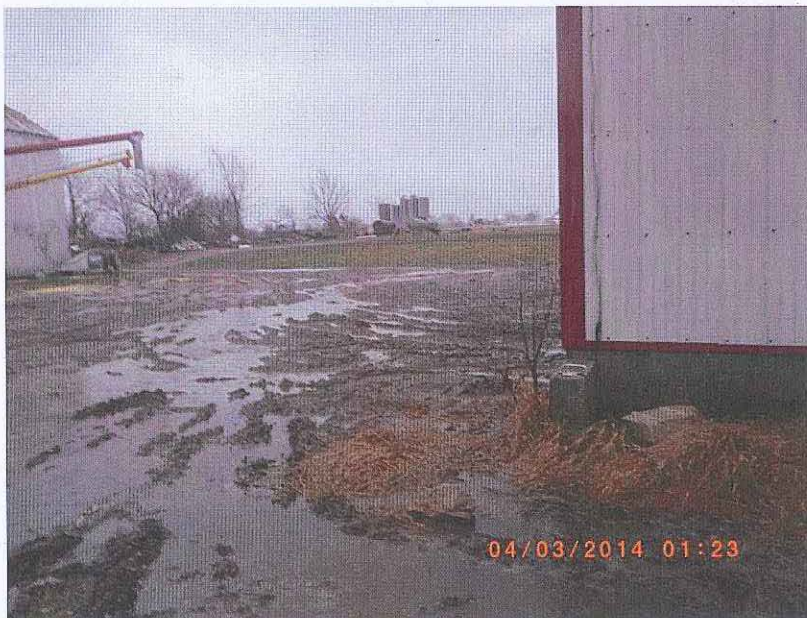
36: IMGP0060

Description: The flow of water from the southeast corner of the Compost Pile goes around the east side of the Wash Bay. Spilled feed on the ground would also flow with the precipitation to the unnamed tributary.

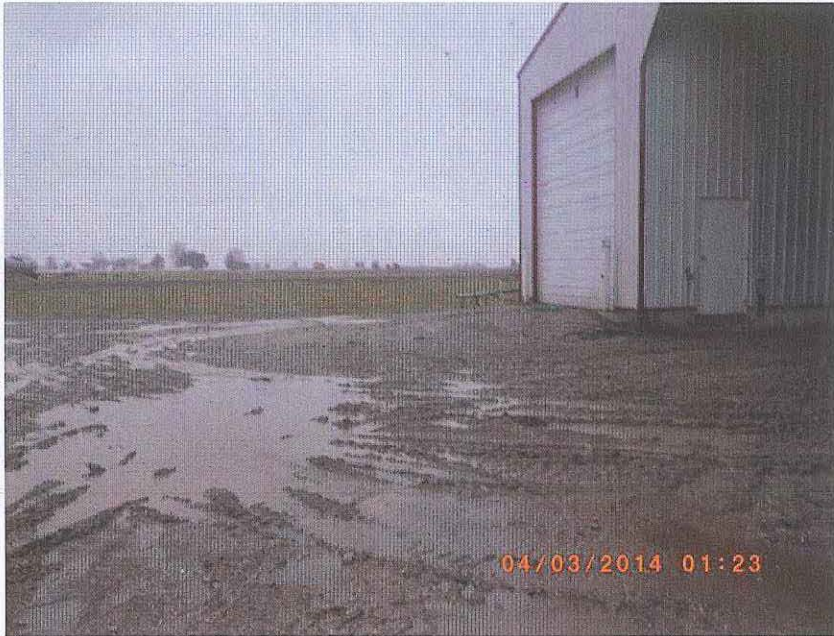
37: IMGP0061

Description: The flow of water from the southeast corner of the Compost Pile goes around the east side of the Wash Bay.

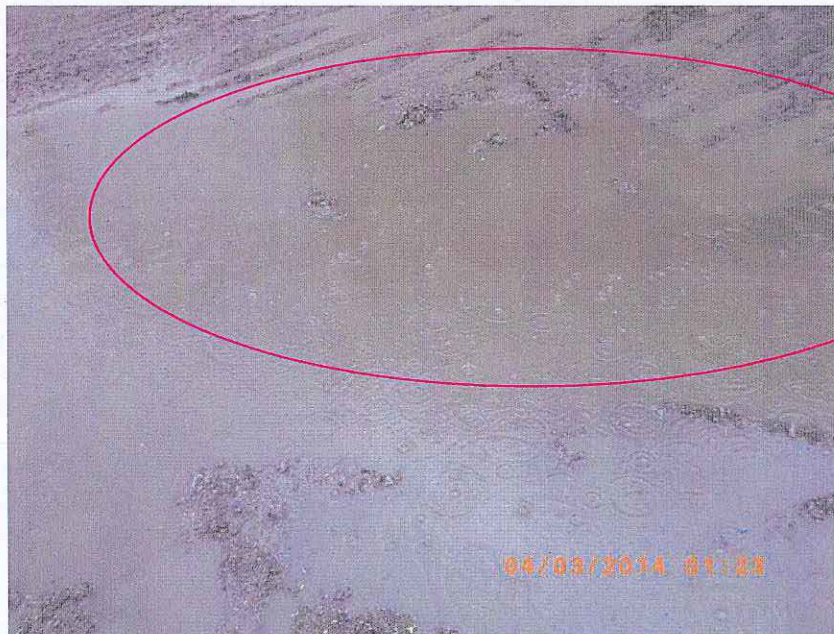
38: IMGP0062

Description: The plume of leachate from the Compost Pile is still visible in the flow pathway east of the Wash Bay.

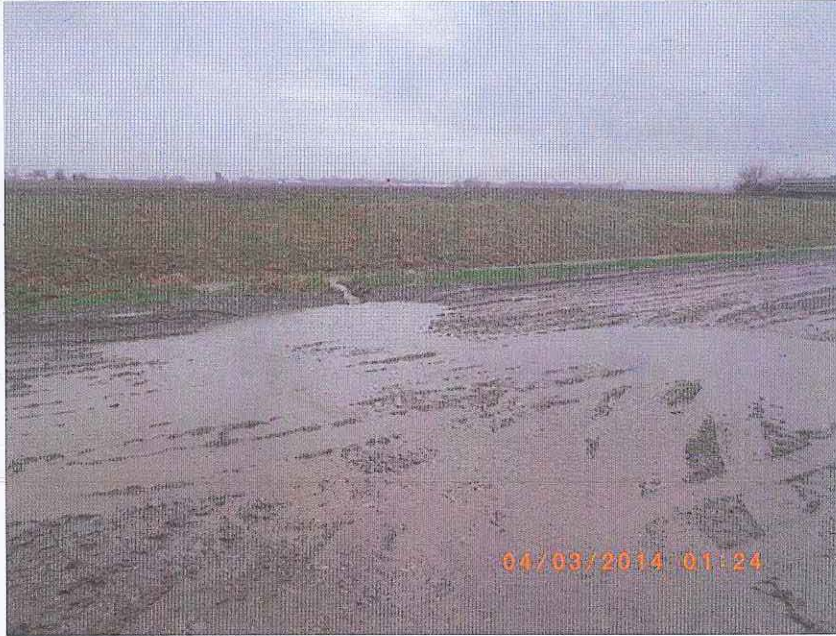
39: IMGP0064

Description: The flow of water from the southeast corner of the Compost Pile channelizes at the edge of the facility access road and flows into the perennial tributary.

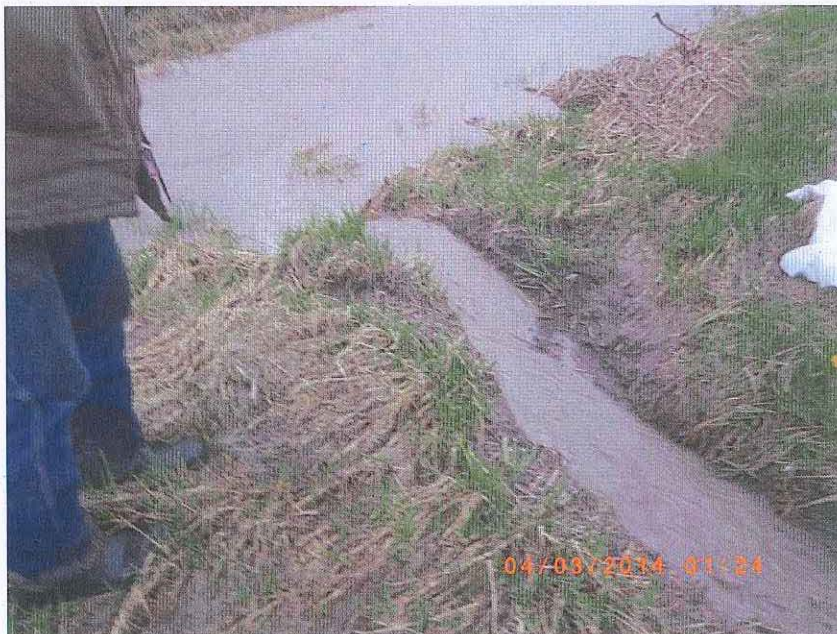
40: IMGP0066

Description: Storm water from the east side of the facility and process wastewater from the Compost Pile and spilled feed on the ground flows into the perennial tributary.
